REPORT NO. FHWA - CA - TL - 78-13

Vehicular Impact Tests Of Precast Concrete Median Barriers With Corrugated Ends And Tensioned Cables

**FINAL REPORT
JUNE 1978**

Caltrans
CALIFORNIA DEPARTMENT OF TRANSPORTATION

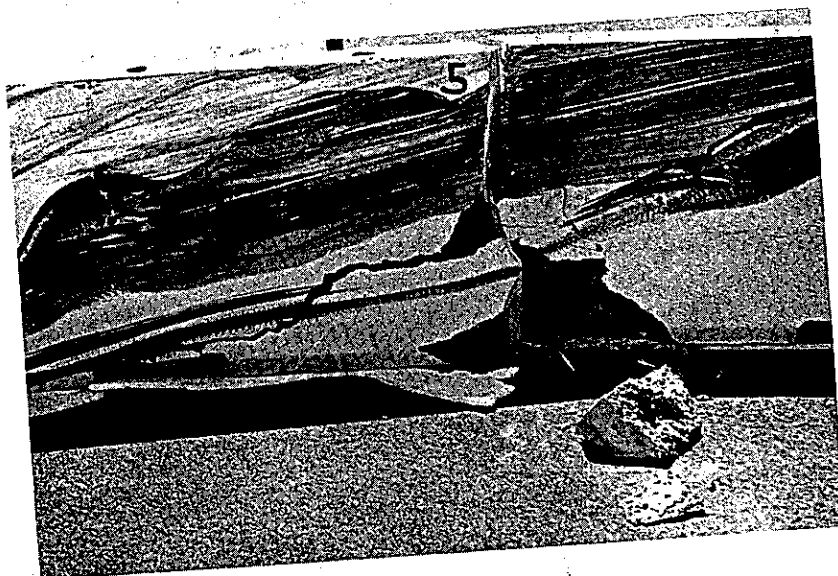
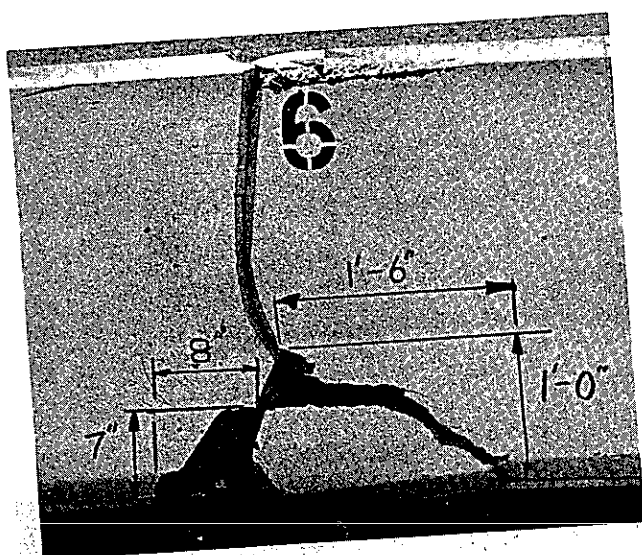
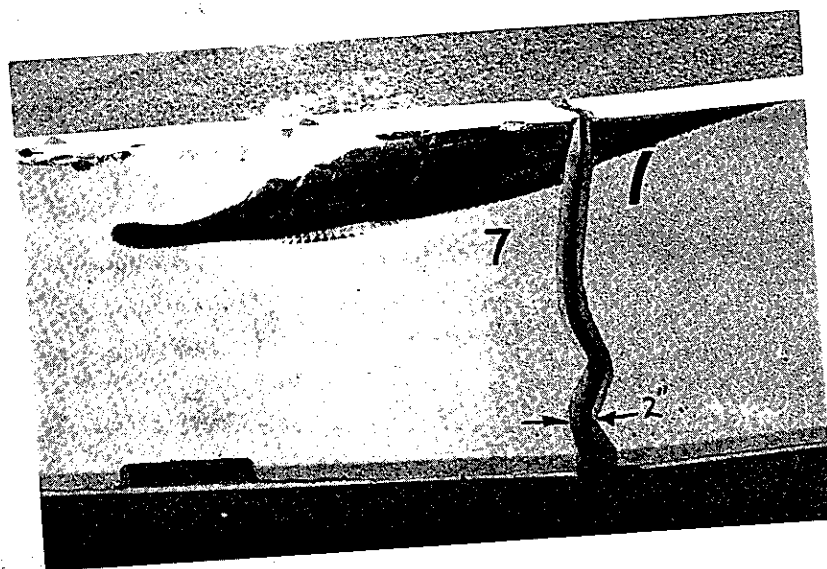
Due to the large deflections and the tight fitting joints there was considerable spalling of the concrete at the corners of the segments, Figures 8 and 9. Figure 10 shows the damage and scuff marks on the barrier where primary vehicle contact occurred.

Figure 8. Barrier Damage and Movement (impact side)
at Joints 3, 4, 5, 6 and 7, Test 331.

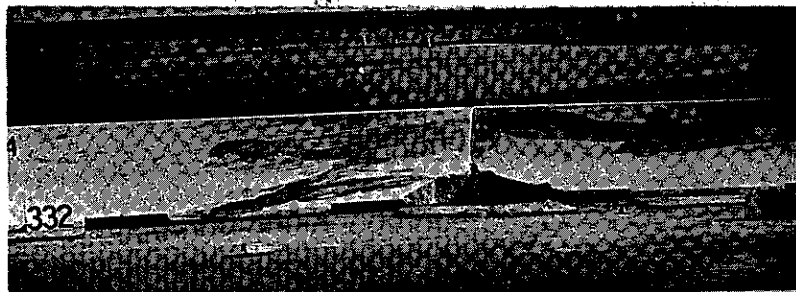
Figure 17. Primary Impact Area, Test 332.

It should be noted that in both Tests 331 and 332 there was extensive spalling of the corners of the barrier segments which deflected. Also, a flexural failure occurred near the middle of the first barrier segment hit during Test 332. These segments would all need to be replaced. This represents less than desirable structural adequacy when compared with the performance of continuous CMB which is typically undamaged in severe impact tests.

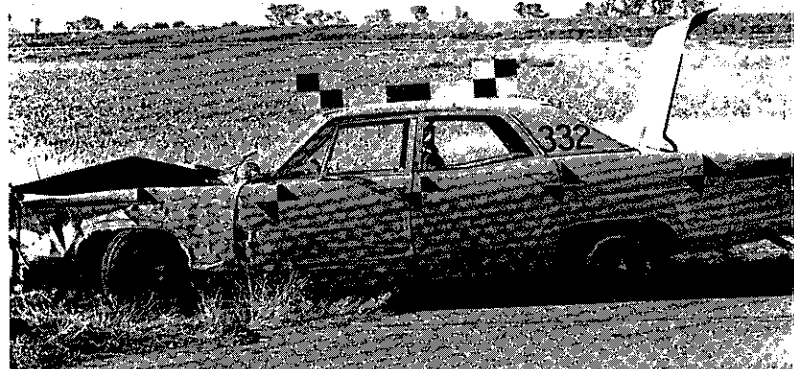
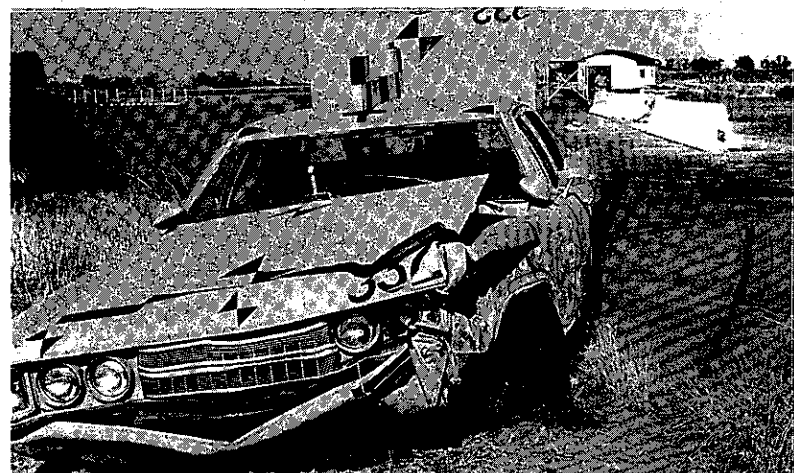
Figure 18. Vehicle Damage, Test 332.

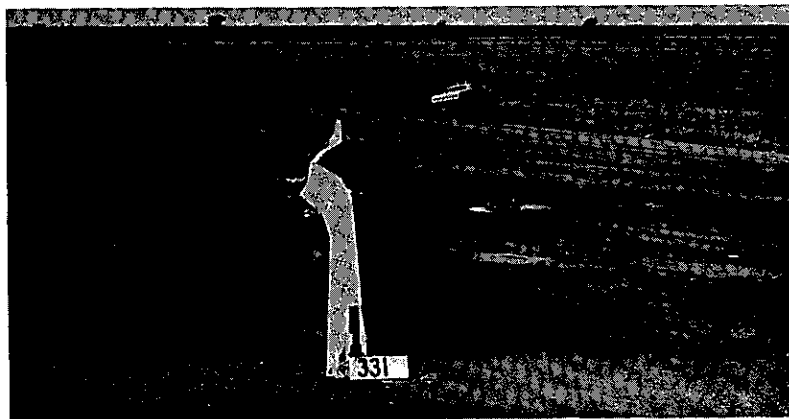
In Test 331 the large barrier deflection caused the vehicle to become airborne on a hazardous trajectory over the top of the barrier. If the barrier had been longer, the vehicle easily might have toppled over the backside of the barrier or rolled over. In Reference 4 more weight was given to tilting of the barrier segments than to lateral deflection as the cause of vehicle vaulting. Due to the low tilt angle of under 6° (0.11 rad) in Test 331 and a lateral deflection more than that in a similar previous Caltrans test, Test 292(4), it now appears that large lateral deflection alone can be a primary cause of vehicle vaulting in severe impact tests. This negates any possible benefits claimed in the form of reduced vehicle decelerations caused by barrier deflection for this type of barrier. It should be noted that differences in vehicle suspensions and crushability also may affect vehicle vaulting tendencies during CMB impacts.

This appraisal factor was covered in the section on Structural Adequacy. In summary, the vehicle trajectory for Test 331 was judged unacceptable. That for Test 332 was relatively good; however, it might have been similar to the one in Test 331 had the vehicle not run over a vehicle guidance system knockoff post. Table 1 and Figures 12 and 19 provide data on the vehicle trajectory. Figures 20 and 21 show the post test trajectories for the two vehicles.

Figure 20, Post Impact Vehicle Trajectory, Test 331

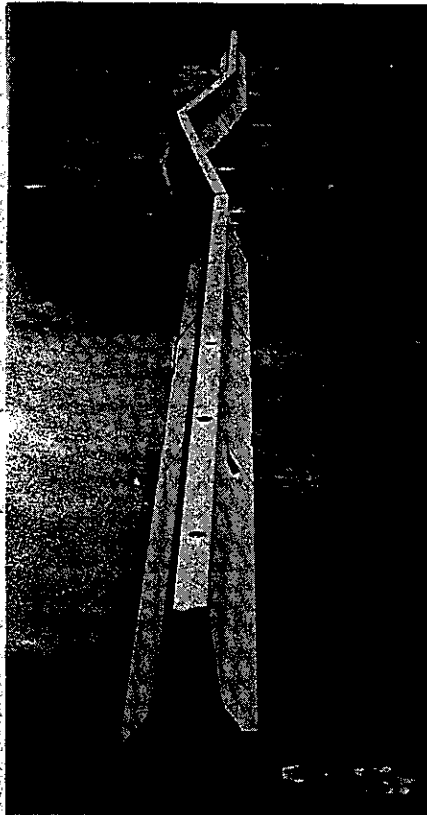
In Test 332 the maximum barrier deflection was an inch more than in Test 331 but the vehicle was redirected in a less hazardous manner than in Test 331. Had the test vehicle not gone over the cable guidance post in Test 332, causing it to roll toward the barrier, it is speculated that the vehicle trajectory might have been similar to that in Test 331.

Figure 21. Post Impact Vehicle Trajectory, Test 332.

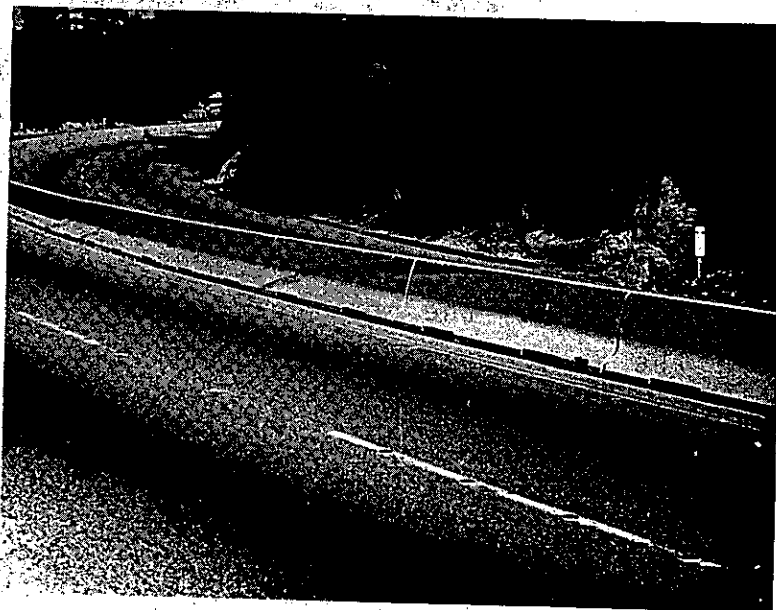
In October, 1977 it was learned that the barrier had been hit and had moved a few inches. Several Caltrans engineers inspected the barrier and observed the following. The barrier had been soundly hit several times. Virtually all the impacts occurred in the southbound direction, and most were within a 200 ft (61 m) length of barrier. At that location there were two 12 ft (3.7 m) wide southbound lanes of asphalt concrete paving headed downhill and curving to the left on a 575 ft (175 m) radius. The median was about 6 ft (1.8 m) wide, Figure 16A.

Figure 16A. Type 50V Barrier, Rte. 17, Santa Cruz County. Looking Northerly.

Due to the high localized accident frequency, the breaking of the grout bond to the barrier segments, and the movement which had already occurred, it was decided to provide additional lateral restraint for the barrier, or replace it with a continuous cast-in-place or slipformed CMB.

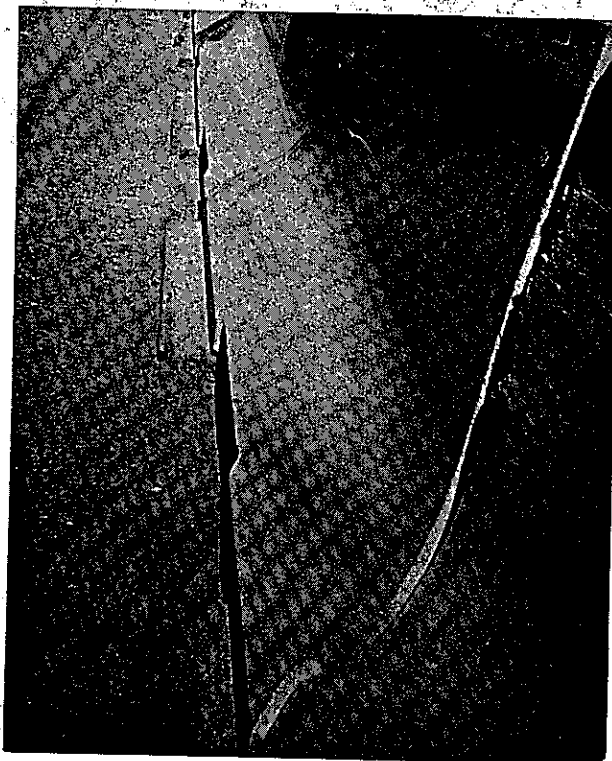
A Caltrans computer data bank revealed the barrier had been hit six times in the southbound direction between January and September, 1977. Eight of the 12.5 ft (3.81 m) barrier segments had broken

loose from their grout pads. The maximum lateral deflection at one joint was four inches (10 mm), Figure 17A. In at least one accident the vehicle straddled the top of the barrier before returning to the southbound lanes. The barrier segments were fairly tight at the joints, which may have been due in part to a tightening of the "arch" of the horizontal curve as the segments moved laterally to the east. At several of these tight joints there was some cracking and spalling of the concrete. One segment had a crack at mid-length running up the west face and part way down the east face.

Figure 17A. Lateral Barrier Movement, Type 50V Barrier, Santa Cruz County.
